# Manhole Inspection Summary

Manhole # S43G\_\_033MH

Insp Date: **5/30/08 11:04 AM**

**Location** Address: **213 bethel st**

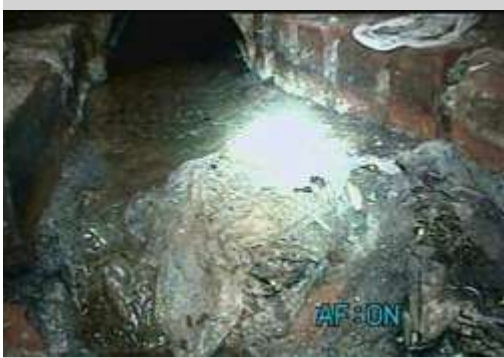
Defect 2

Condition: ☐ Sound ☐ Cracked ☐ Root Intrusion ☐ Deteriorated ☐ Leaks ☒ **Debris**

channel debris

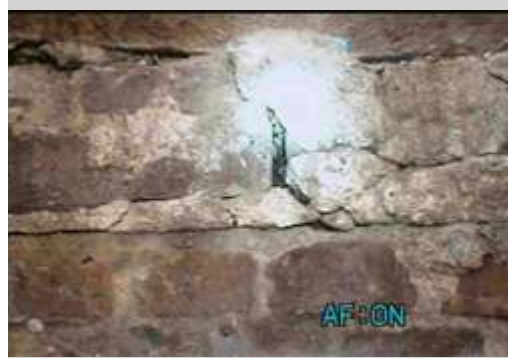
Defect 1

Condition: ☐ Sound ☒ **Cracked** ☐ Root Intrusion ☐ Loose Brick ☐ Deteriorated

chimney cracked, adj

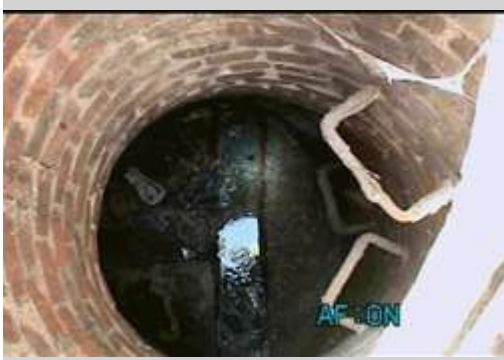
Defect 3

**Steps** Count: **4** Missing: **0** ☒ **Corroded**

corroded steps, bench debris

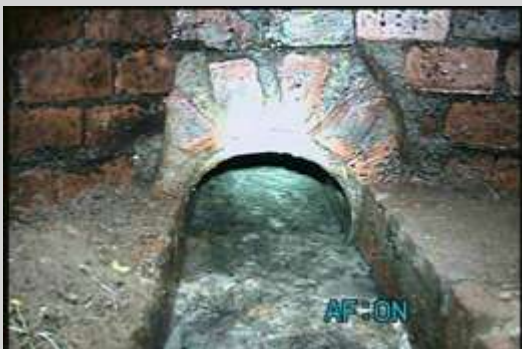
6 O'Clock Inflow

Deposits: ☐ None ☐ Mud ☐ Sludge ☒ **Debris** ☐ Grease

Silt Depth: 4 (in.) Deposits Extent: **Medium**

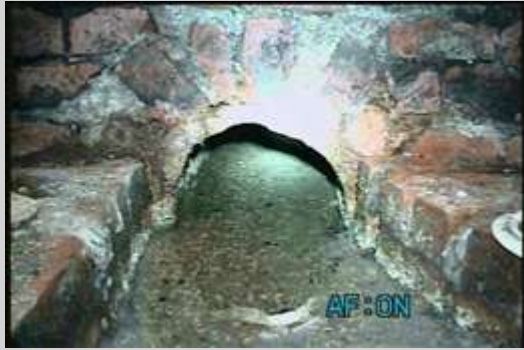
9 O'Clock Inflow

Deposits: ☐ None ☐ Mud ☐ Sludge ☒ **Debris** ☐ Grease

Silt Depth: **3** (in.) Deposits Extent: **Medium**
